RAILWAY INVESTIGATION REPORT

R04Q0047

MAIN-TRACK DERAILMENT

CANADIAN NATIONAL

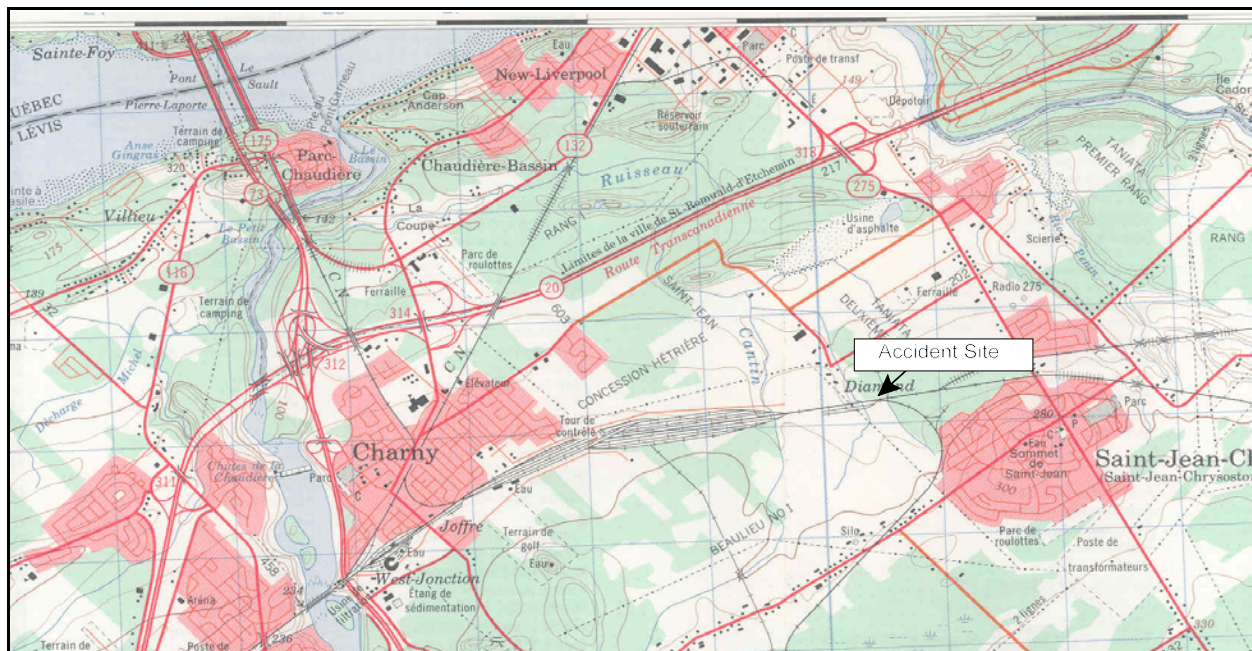
Figure 1. Accident site

The train derailed while rolling over the crossover between the passing track and the main track of the Montmagny Subdivision at Mile 114.8 (see Figure 1). The Joffre Yard passing track is adjacent to and south of the main track. It is approximately 16 000 feet long. At the east end, where the derailment occurred, it connects to the main track through a crossover consisting of two turnouts with number 20 switches. The track consists of 136-pound continuous welded rail on hardwood ties. The maximum speed authorized for freight trains on the passing track is 15 mph.

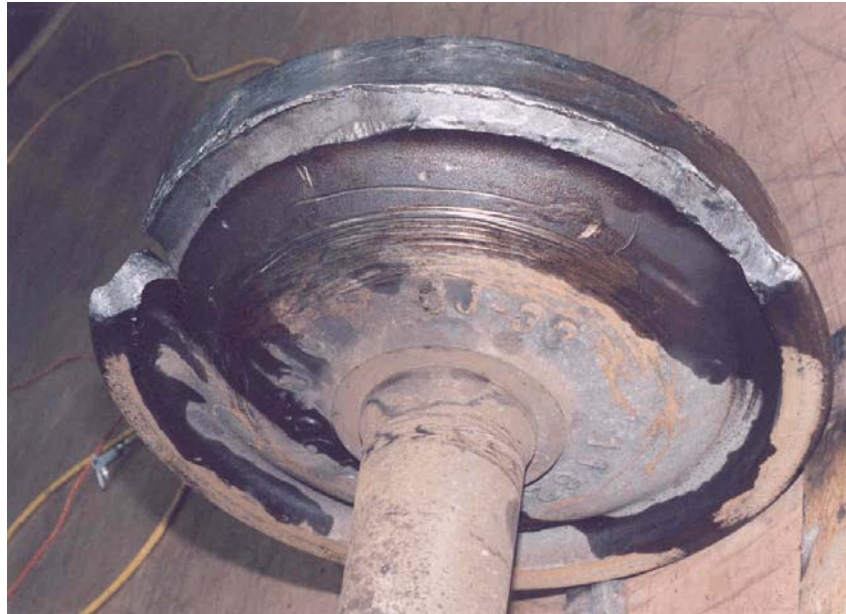
The derailed cars remained upright and coupled. They were immediately east of the crossover, and the last derailed car came to rest over the passing track turnout switch point. Examination of the derailed cars revealed that the rim of the lead wheel of the trailing truck on the first derailed platform of car DTTX 25029 was broken and that a portion of the rim and a 38-inch section of the wheel flange were missing (see Photo 1). The mate wheel exhibited no flaws. The roadbed and right-of-way were inspected over a distance of 3.5 miles to the west of the passing track turnout, but the broken pieces of wheel rim were not recovered. East of the turnout, impact marks were visible on the ties, spikes and tie plates on the south, outside of the track.

Photo 1. Fracture of rim of wheel L-3 of car DTTX 25029

- The surface of the fracture on the outer portion of the wheel rim had a dark area, located about 5 mm below the running surface, with semi-circular features and changes in colouration consistent with progressive fatigue cracking. One crack extended from this area towards the centre of the wheel plate. Observation of the crack contact surfaces revealed chevron markings and secondary cracks with polished sides.
- Metallurgical analysis of rim samples revealed a high level of porosity due to voids left by bubbles of dissolved hydrogen trapped during manufacture of the wheel. Some cracks propagated from these voids. The hardness and chemical composition of the wheels were within AAR specifications.

Based on the analysis by the TSB Engineering Laboratory, the major portion of the fracture of the outer part of the wheel rim was caused by instantaneous overstress. However, the direction of the chevron markings observed on the fracture surfaces indicates that the crack originated in the rim and progressed into the wheel plate. The walls of the secondary cracks were polished, indicating that they had been progressing for some time.

The high level of porosity observed shows that the wheel was not properly cooled, which resulted in trapped hydrogen bubbles and the creation of voids. As a result of service stresses, sub-surface cracks propagated from these voids and subsequently combined to form a larger crack below the running surface. Even though a portion of the wheel rim was not recovered, the presence of porosity and cracks and their positions indicate that the wheel failed when the sub-surface fatigue cracks intersected with the cracks caused by the shelling spots on the running surface.

1. The train derailed following a wheel failure on car DTTX 25029.
2. The wheel failed when sub-surface cracks propagated from porosity and intersected with cracks caused by shelling of the running surface.

The Association of American Railroads (AAR) has issued an instruction for the removal from service of all Southern wheels manufactured in 1995 when cars are in repair shops or tracks.

Canadian National and Canadian Pacific Railway have initiated programs that go beyond the requirements of the AAR. They are removing all Southern wheels from their equipment and have instructed their suppliers to not install Southern wheels on any cars owned or leased by them.

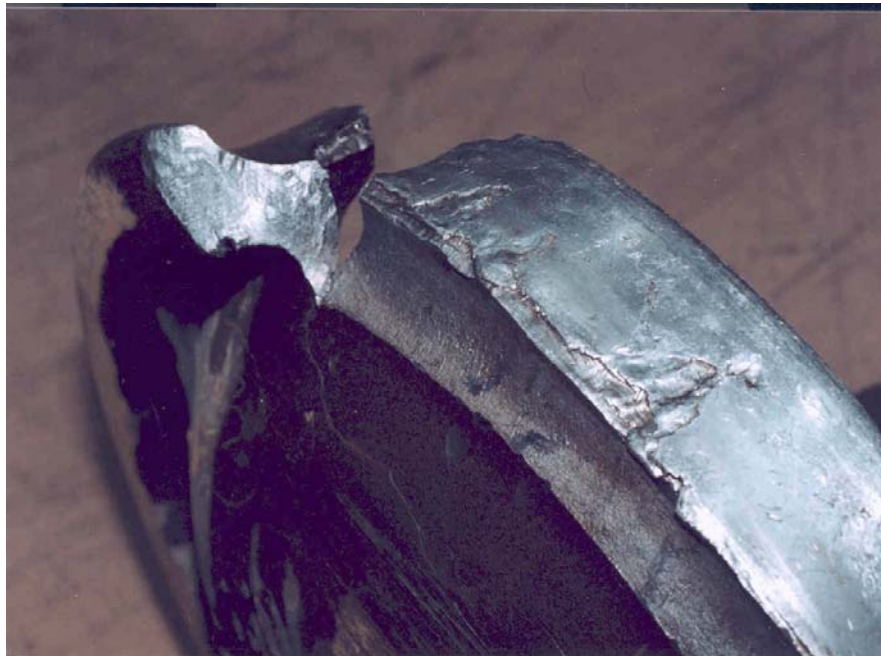
- The running surface of the failed wheel exhibited shelling spots adjacent to the wheel flange, one with a diameter of 1.7 inches and the other with a diameter of 2.4 inches (see Photo 2). The 2.4-inch shelling spot was not continuous, but the 1.7-inch shelling spot exceeded the limit prescribed by the Association of American Railroads (AAR), which requires that wheels with continuous shelling spots on the running surface measuring 1 inch or more in diameter be taken out of service. There were no indications or flaws due to heating.

Photo 2. Shelling on the running surface

The sub-surface cracks observed on the failed wheel could not have been detected by hot box detectors because they originate and propagate with no significant emission of heat. However, the failed wheel had exceeded the limits allowed by the AAR for shelling of the running surface, although neither the safety inspection conducted at Brampton nor the WILD near Bagot identified it as defective. Since there is nothing to indicate that these different inspections were not carried out in accordance with existing standards, there is reason to believe that there are still some cases where the existing safety barriers can be inadequate, either because of the performance of the barriers themselves or because some flaws can develop rapidly.
